DYNAMIC SCIENCE, INC.
In-Depth Accident Investigation

Case DSI-94-SB-08

TECHNICAL SUMMARY

DYNAMIC SCIENCE, INC.
ACCIDENT INVESTIGATION
CASE NUMBER: DSI-94-SB-08

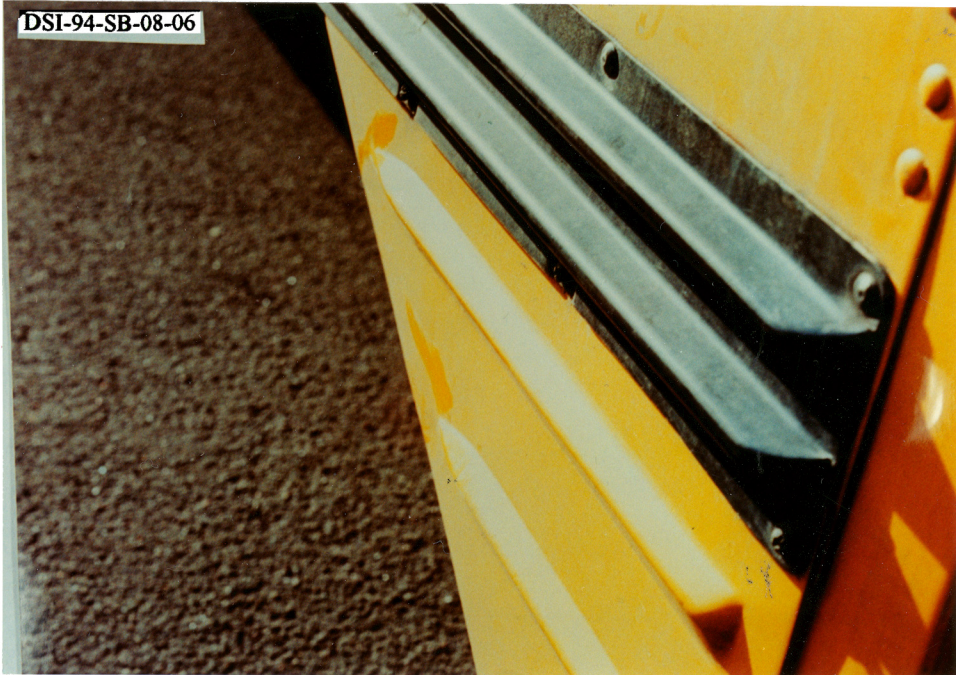
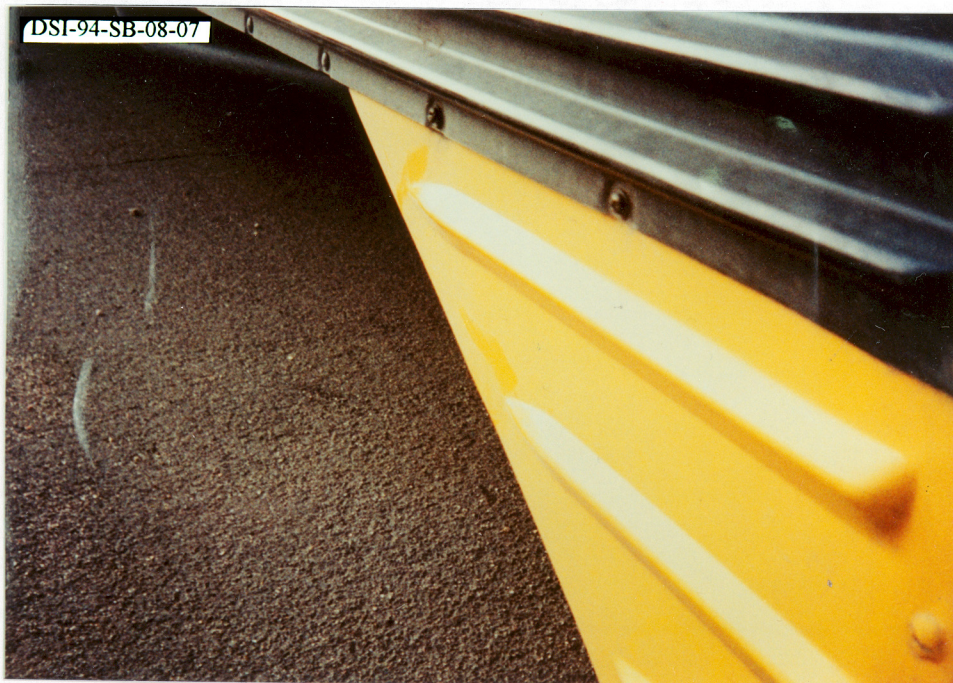
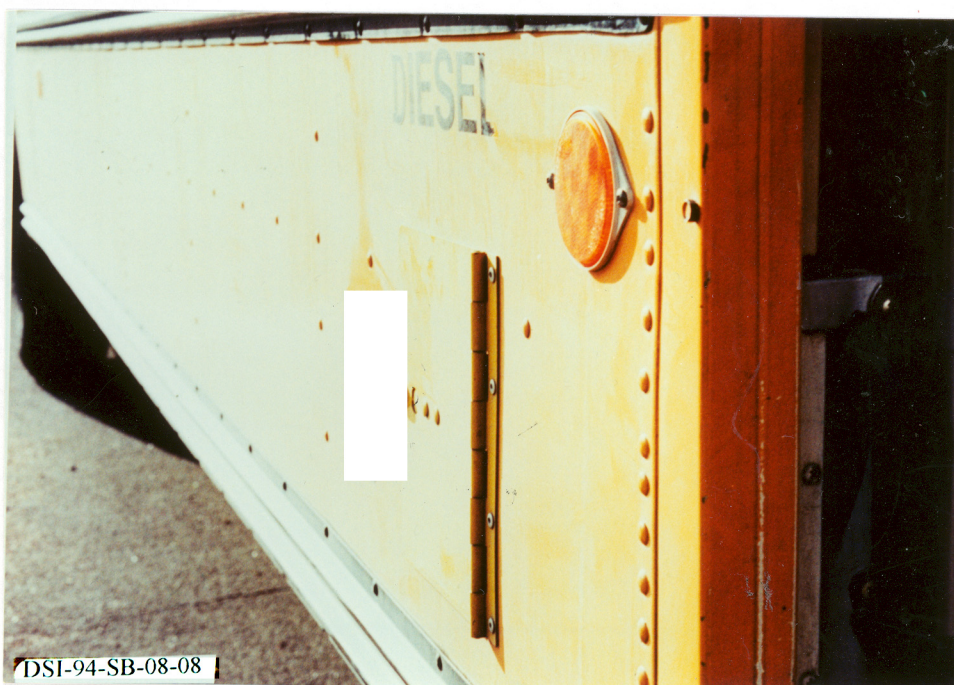
PHOTO NO.	VEHICLE NO.	DIRECTION OF PICTURE	SUBJECT MATTER
1	1	East	Area of impact and final rest.
2	1	West	Final rest. Note: Vehicle was moved by the driver approximately 30 feet after the accident.
3	1	West	Final rest.
4	1	NA	Orienting view of bus.
5-8	1	NA	Close-up views showing scuff marks from contact with case subject.
9	1	NA	Orienting shot showing entangled strap.
10-12	1	NA	Entangled strap.
13	1	NA	Scuff marks from case subject.
14	1	NA	Overview of step well, handrail.
15-17	1	NA	Closeup views of entangled strap.
18-21	1	NA	Closeup views of strap in relation to case subject's backpack.

DURING THE PHOTOGRAPHY SEGMENT OF OUR INVESTIGATION, THREE DISTINCTIVE MARKS (SURFACE DIRT HAD BEEN RUBBED AWAY) WERE OBSERVED ON THE RIGHT SIDE OF THE SCHOOL BUS ALONG THE BLACK METAL STRIPPING INDICATING CONTACT.

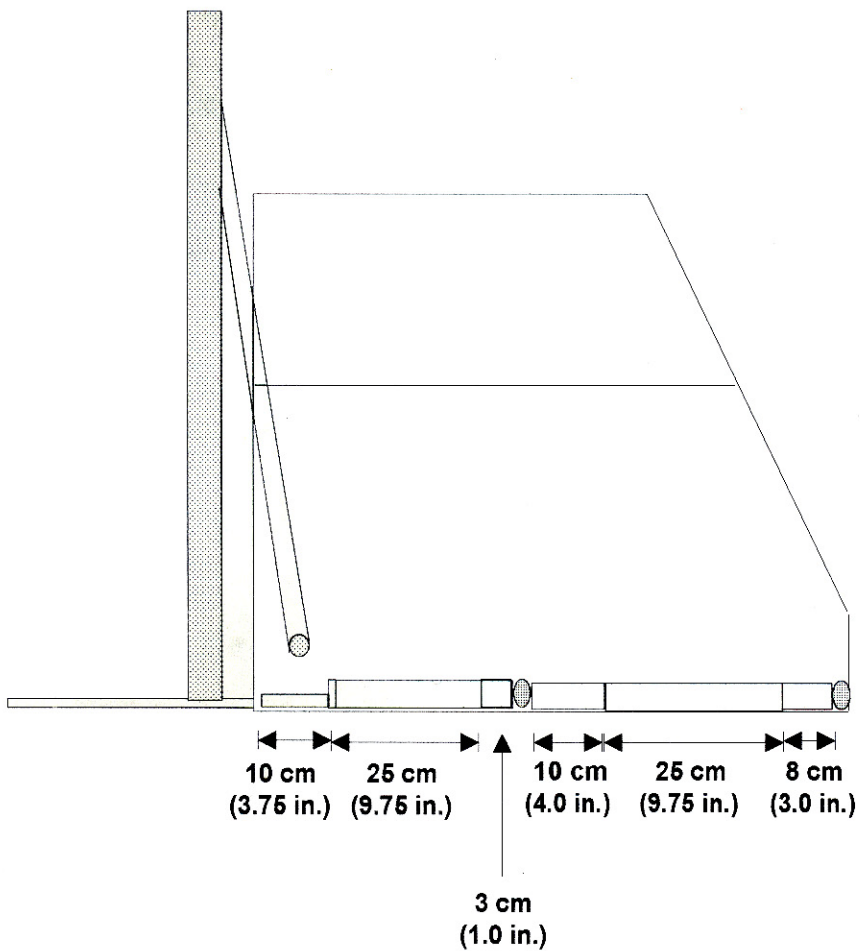
Handrail/Stepwell

I ENTERED THE SCHOOL BUS TO SPEAK TO THE STUDENTS WHO WERE STILL SEATED ON THE BUS. WHEN I STARTED UP THE STAIRWELL I OBSERVED A BLACK STRAP HANGING FROM THE HANDRAIL NEAR ITS BASE AT THE POINT OF EXIT, MEASURING APPROXIMATELY 3' 01" HEIGHT FROM GROUND.
